TEST REPORT

Fire Resistance

*Carried out to the principles of
BS EN 1634-1:2014*

A HINGED SINGLE LEAF DOORSET
LEAF SIZE 1905mm x 860mm x 1905mm
Report Ref
FSSR/FRT/240
Test Date
8TH October 2019

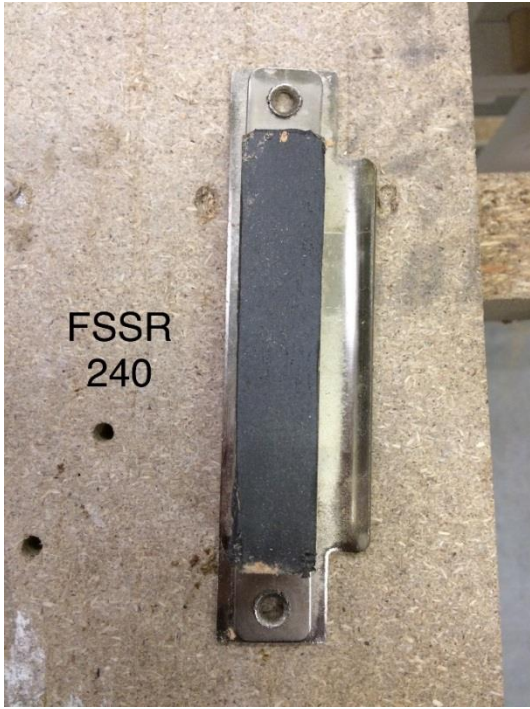
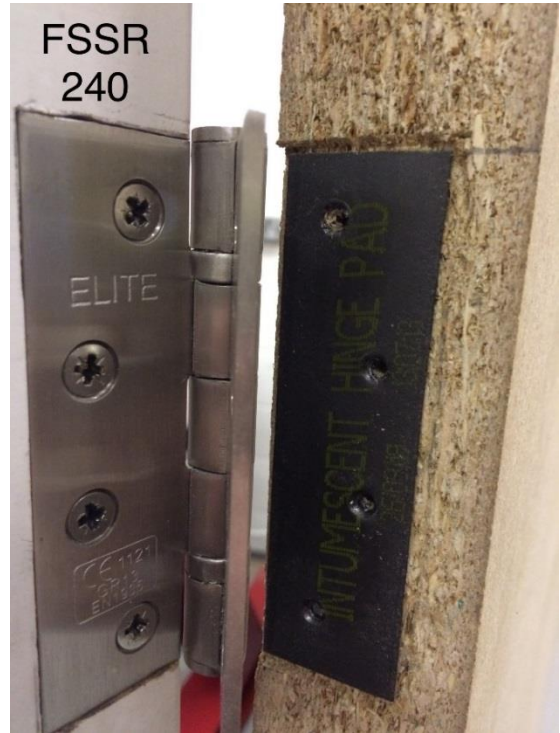
Intumescent behind Hinge

Intumescent behind lock

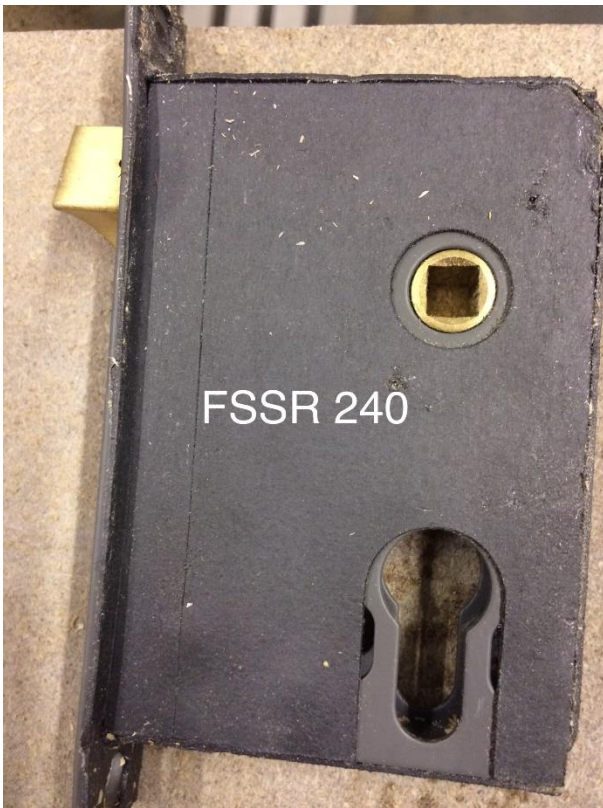
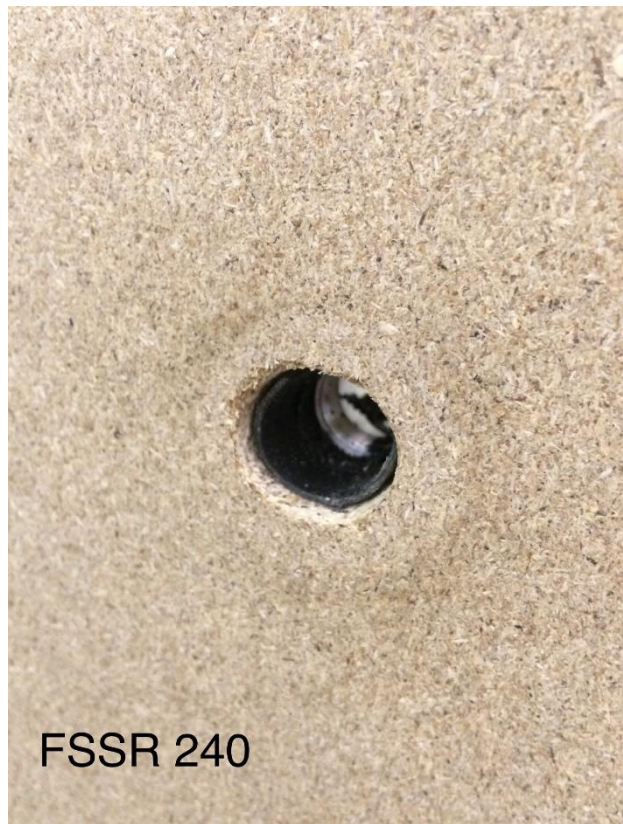
Intumescent behind Door Viewer
